MARINE INVESTIGATION REPORT

M00N0089

CAPSIZING

OPEN BOAT CFV *127606*

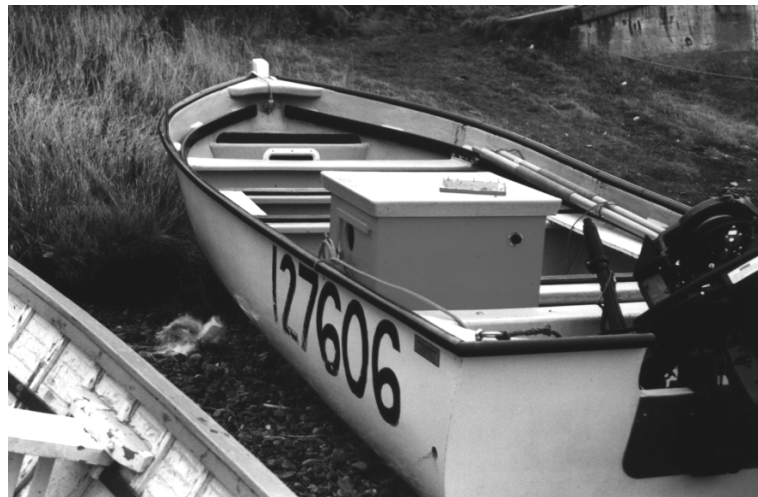
Photo 1. The CFV 127606 after recovery (oars in stowed position)

The underside of the skeg at the stern showed recent signs of abrasion and the outboard motor cover had been lost. The propeller blades had suffered severe damage and a steel guide pin, securely mounted on the transom, had been bent over by some strong external force. The oars were in the stowed position (see Photo 1).

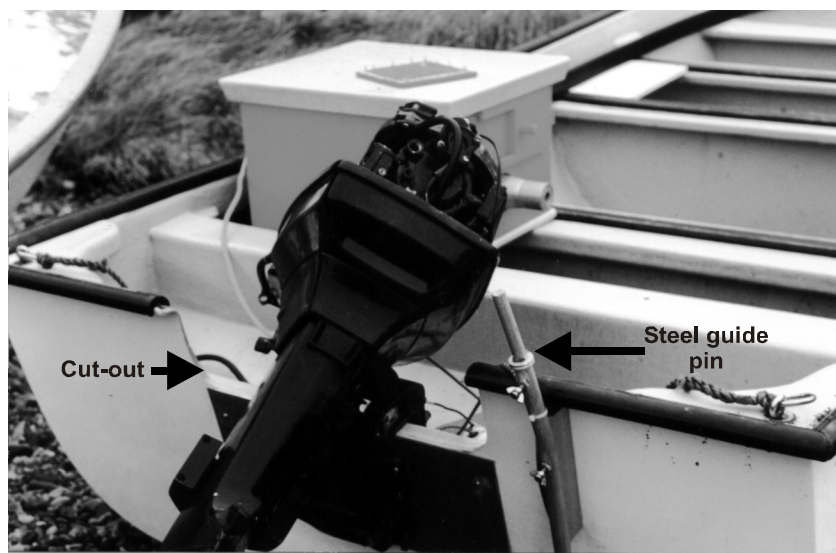
The outboard motor is mounted in way of a cut-out at the centre of the stern transom. The lower edge of the cut-out is below the projected line of the gunwale rail and, being the lowest point of freeboard, is an area of the hull most prone to shipping water during fishing operations. A net/line hauler is housed in a weathertight enclosure located at the port side of the compartment just forward of the operator well (see Appendix A, Photo 2).

Photo 2. View of stern cut-out for outboard motor, with net/line hauler in background

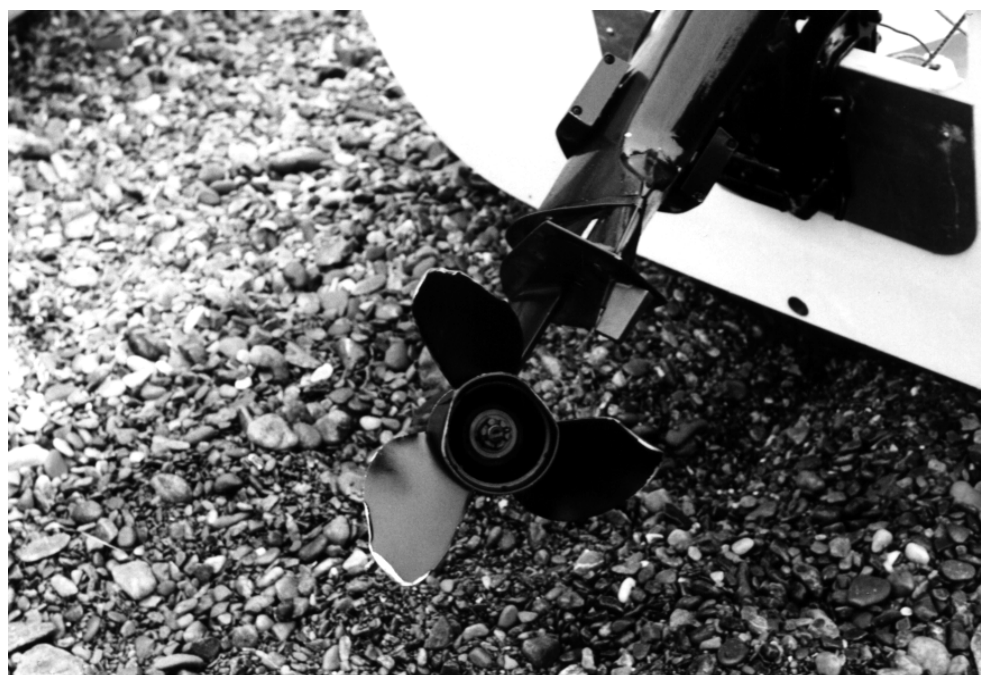
From the damage to the skeg and the propeller, it was evident that the vessel had struck a rocky shoal before the vessel capsized.

Photo 3. View of damaged propeller blades
